Introduction

This report describes the testing performed to certify that the ECI 480 volt surge arrester catalog number 9F96DA480 meets performance requirements as specified in IEEE C62.11-1999 modified in a manner required to make the test meaningful for a device rated below 1KV. Since several facilities were selected to perform the testing based on their respective capabilities, this report is a summary of a number of different test reports. Participating laboratories were evaluated by ECI prior to testing to insure that the proper capability existed.

480 VOLT MOV SURGE ARRESTER WIRE

Report No. ECI-052004LVA

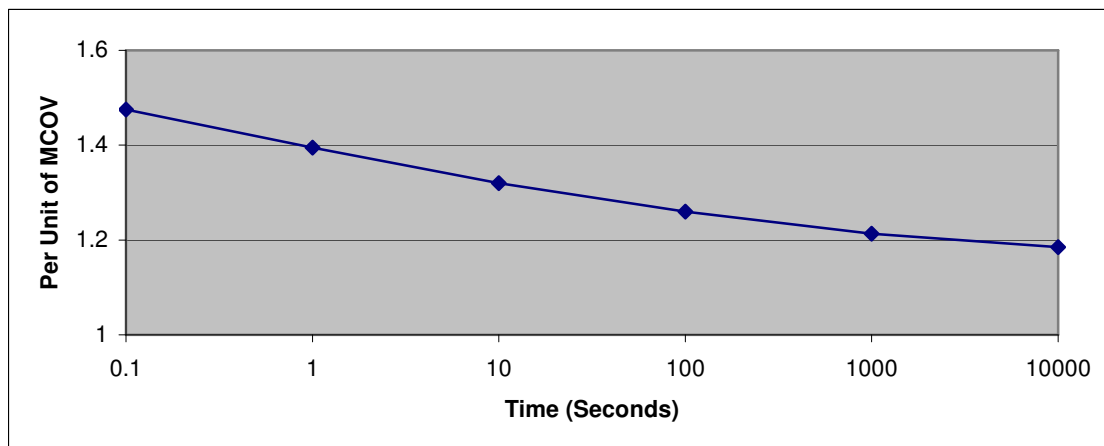
Graph 1 TOV Recovery Curve

Time, Seconds	Per Unit of MCOV
0.1	1.475
1	1.395
10	1.32
100	1.26
1000	1.213
10000	1.185

Table 2

A no prior duty test was performed on complete arresters. The results are shown in graph 1 and table 2 in Appendix 1. TOV capability as defined by IEEE C62.11-1999 was demonstrated.
